Manhole Inspection Summary

Manhole # S09AA2018MH

Insp Date: **7/17/06 9:56 AM**

Location Address: **5811 STUART AVE**

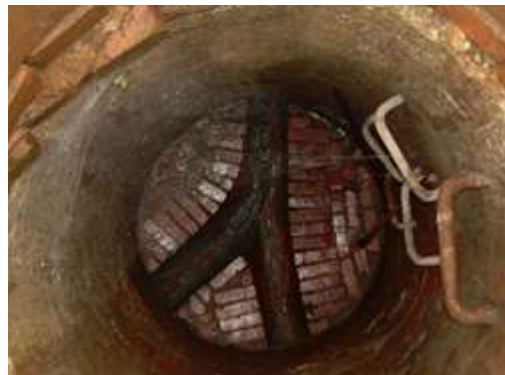
Top View

Corroded steps. Evidence of surcharge - Bench debris.

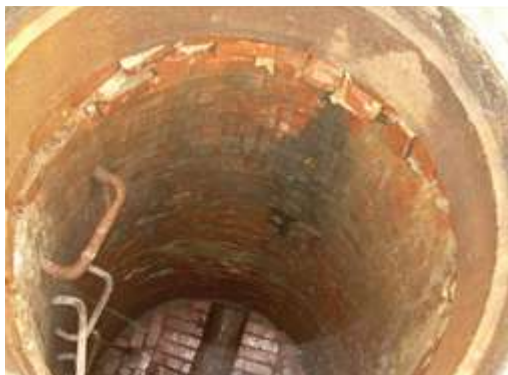
Defect

Frame leaks. Adjustment deterioration, loose brick and infiltration. Corbel and Barrel infiltration.

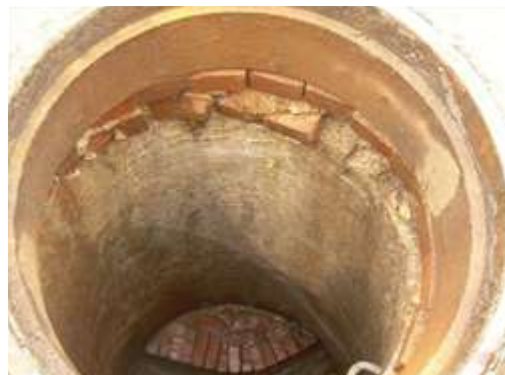
Defect

Frame leaks. Adjustment deterioration, loose brick and infiltration. Barrel infiltration.

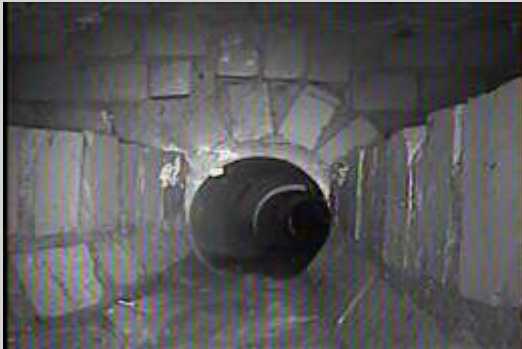
8 in. Circular Gravity Sewer Pipe Out @ 12 O'Clock

Infiltration: **Evidence** Pipe Seal Cond: **Unknown**

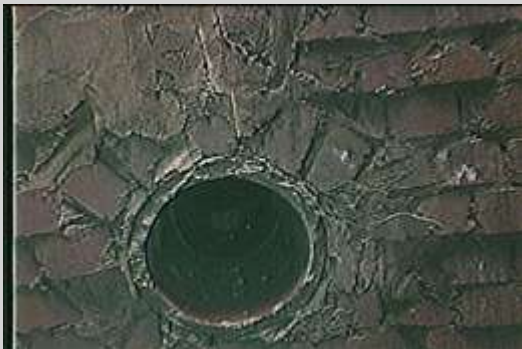
8 in. Circular Gravity Sewer Pipe In @ 5 O'Clock

Infiltration: **Evidence** Pipe Seal Cond: **Cracked**

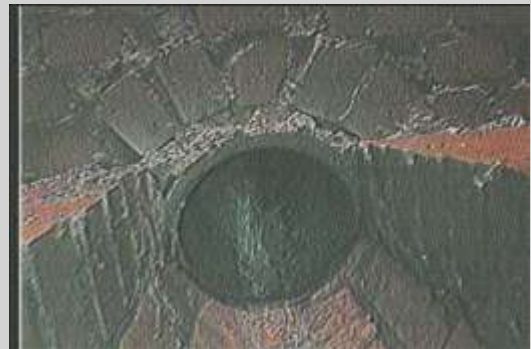
Drop In @ 5 O'Clock

Barrel deterioration and infiltration. Channel deterioration.

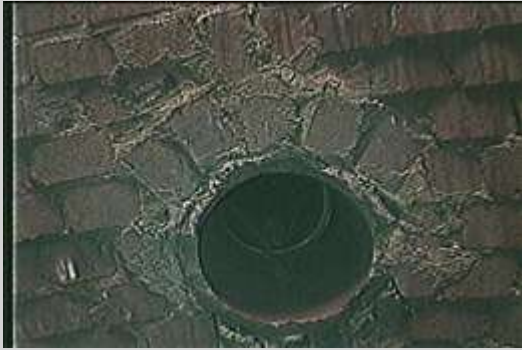
Pipe In @ 8 O'Clock

Infiltration: **Evidence** Pipe Seal Cond: **Cracked**

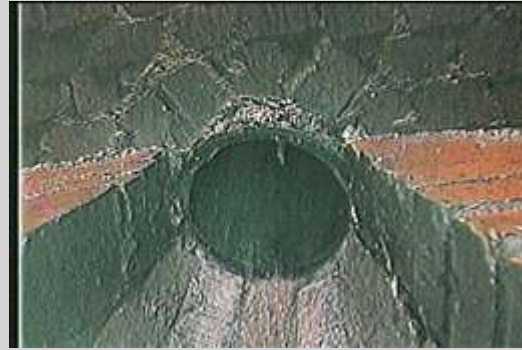
Drop In @ 8 O'Clock

Barrel deterioration and infiltration. Channel deterioration.
